# FURE'S CABIN

## HISTORIC STRUCTURE REPORT

FURE'S CABIN

KATMAI NATIONAL PARK & PRESERVE

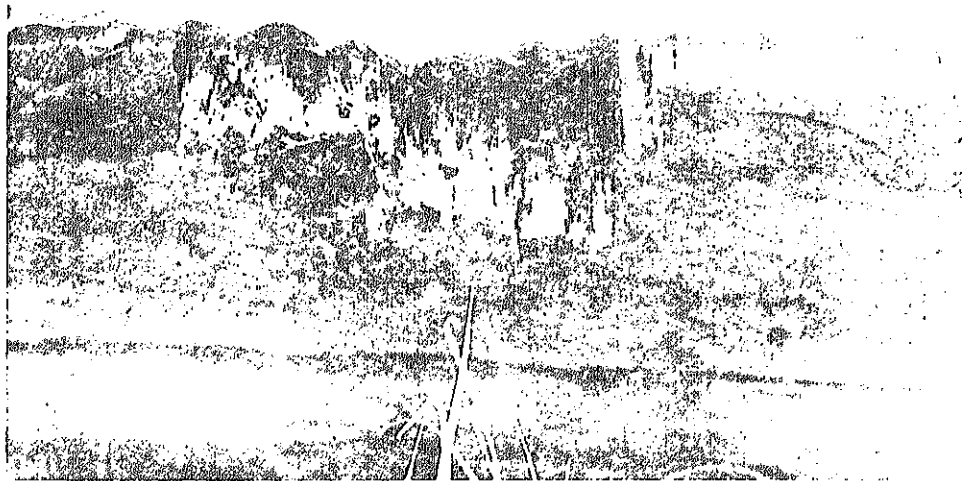
There is also visual evidence of a roof leak at the north end of the west wall that is directly affecting floor planks in that vicinity. Planks are generally mushy near sill walls and bearing points evidencing direct moisture contact.

Photograph 16  
Roof Plank Edge at North End of  
West Elevation  
6/28/83 D.C. Anderson

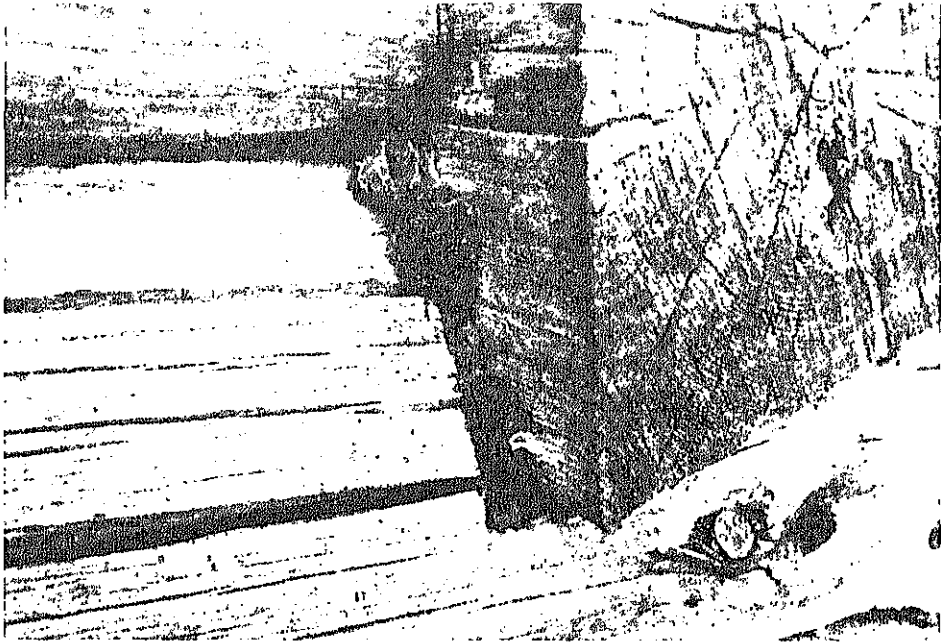
The corner joints are all dovetailed with a high degree of craftsmanship and still fit tight. At various points there is evidence of large spikes having been driven into the dovetailed joints. All end-grain of these joints is painted with red paint. The paint appears to have been a regular maintenance operation in the upkeep of this structure performed by the owner, Roy Fure. The paint has remained in fair condition, thus slowing deterioration at the log butts.

Photograph 43  
Typical Dovetail Joint: Note  
Paint on End Grain  
6/82 D. Snow

- 13) Paint all dovetail end grain with red oxide after priming with mixture of 50% boiled linseed oil and 50% turpentine.
- Window Repair 14) Repair all existing windows: repair or replace glass and repairing or restoring sash. Paint restored sashes and glazing compound. (Several weeks may be required for glazing compound to set up.)

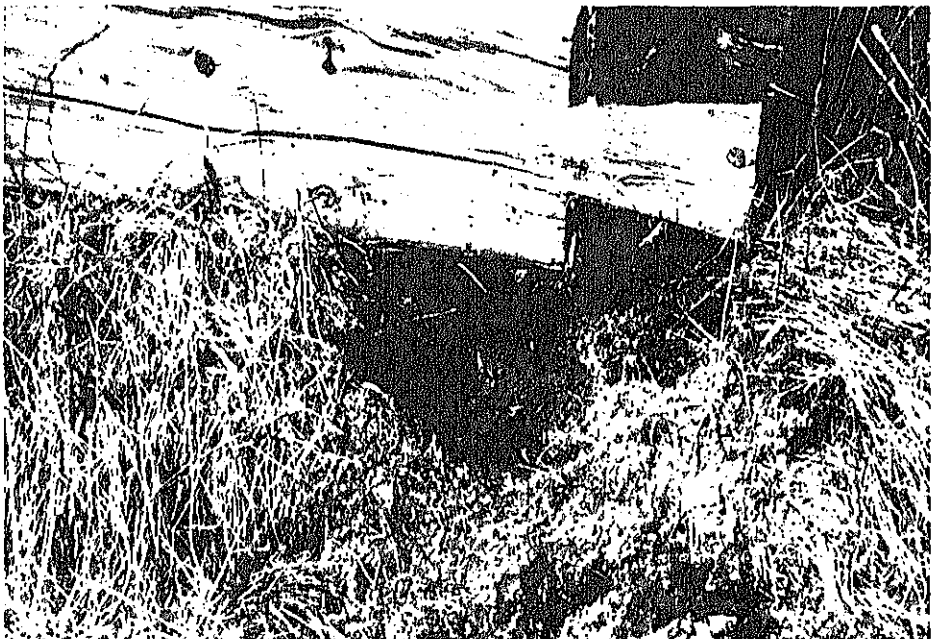
The existing condition of the sill logs is obvious because they have been in constant contact with the soil since the cabin was constructed. There is uniform dry rot primarily below the grade. This problem is compounded at the north elevation and the north end of the west elevation because the structure is built into the hillside. At least three courses of these wall logs, above the floor level, are in direct contact with soil at their exterior face.

Photograph 44  
Northeast Corner: Note  
Rotted Sill Log  
6/82 D. Snow

| | 2) Remove sill logs that have lost their structural integrity and replace with pressure-treated timber (Douglas Fir) as indicated in Stabilization Drawings. |

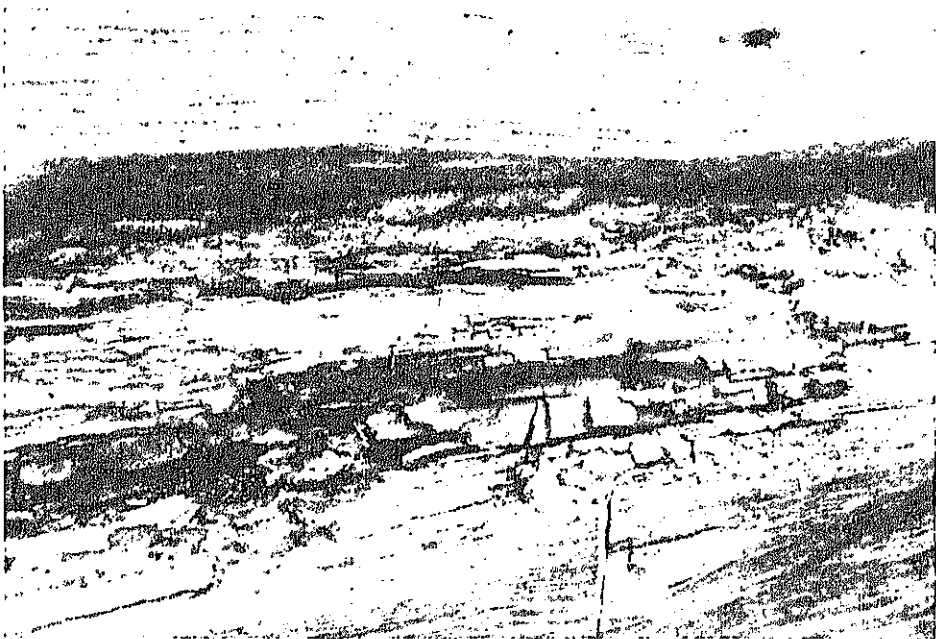
Photograph 48  
North Elevation of Cabin Above Window:  
Note isolated Dry Rot  
6/82 D. Snow
